# Inspection Report

**INSPEKT.ca**

27 Rean Drive, Toronto, ON, M2K 0A6

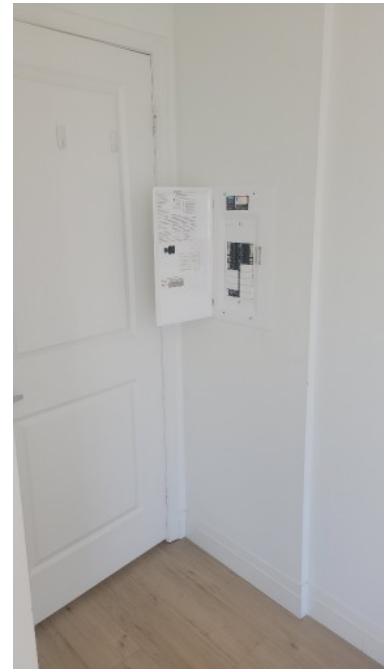
#### 1.1) Distribution Panel Location

Bedroom

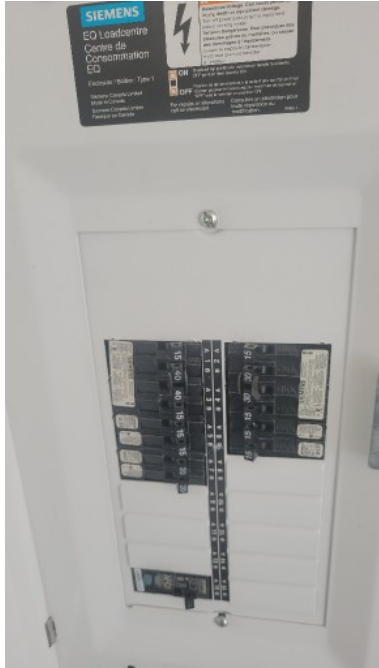
#### 1.2) Electrical Panel Condition

AS

The Electrical Panel is equipped with circuit breakers and all breakers were on during the time of inspection. The panel appears to be generally in good condition and is labeled. A full assessment of the electrical panel, electrical load capacity, and circuit performance is beyond the scope of a visual inspection. For a full electrical evaluation please contact a licensed electrician if any issues arise or for any planned upgrades.

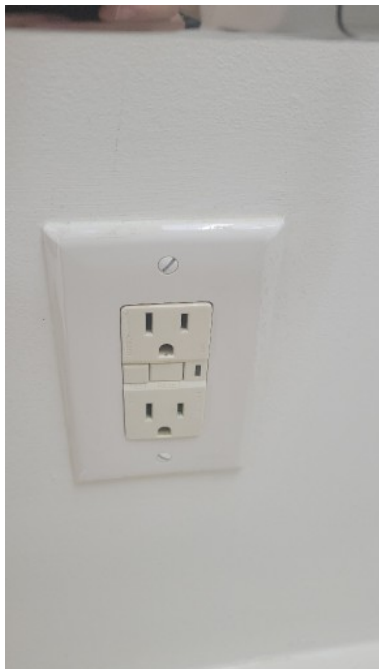
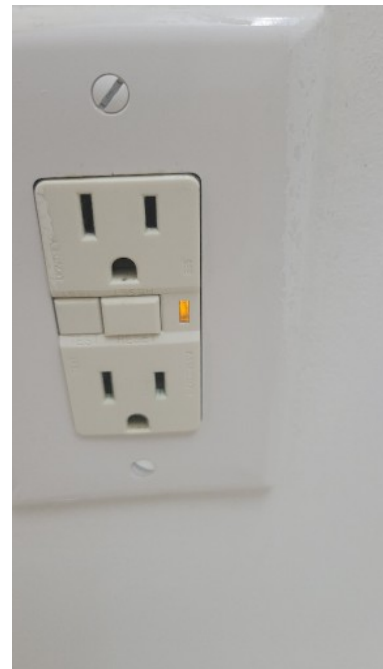
### 1.3) Circuit Interrupters

AS

Ground Fault (GFCI) & Arc Fault (AFCI): GFCI'S present and appeared to be in working or usable condition with no major discrepancies noted during the time of inspection.

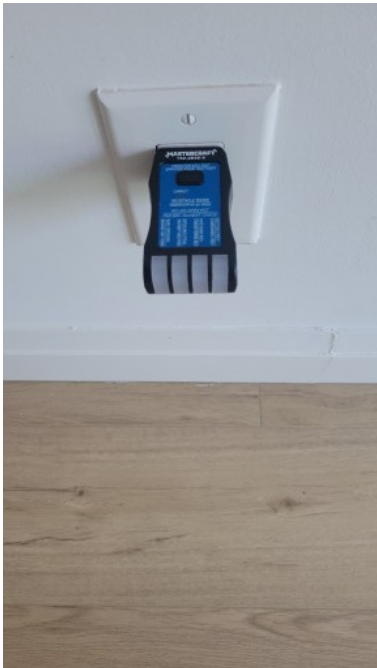
#### 1.4) Outlets (receptacles)

R

All accessible electrical receptacles were tested during the inspection. The receptacles appeared to be in working and usable condition, with the exception of the middle receptacle on the east wall of the living room, as shown in the accompanying photo. This receptacle did not operate as expected. Repair or further evaluation by a licensed electrician is recommended.

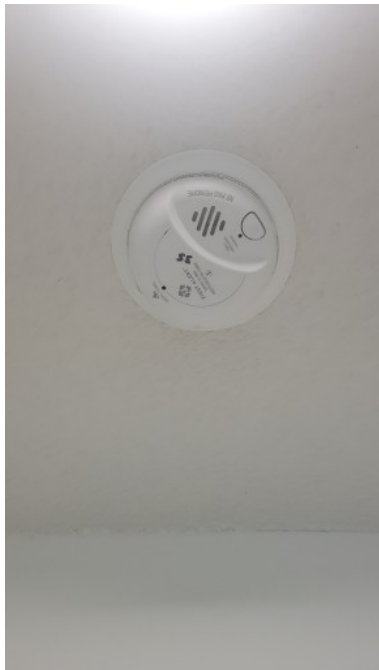
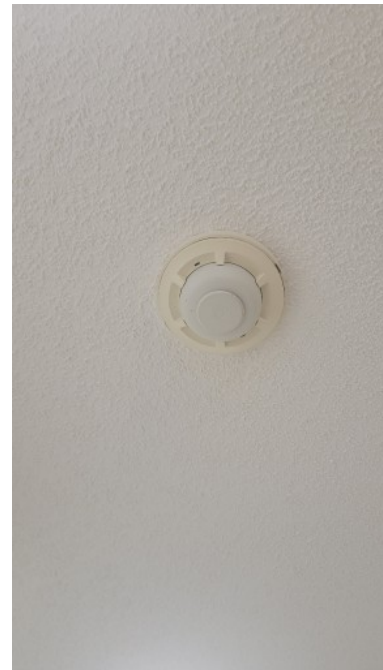
**1.6) Smoke Alarms (detectors)**

AS

Present

Condition: Recommend to test all smoke and carbon monoxide detectors (alarms) monthly, replace battery annually and replace detectors every 10 years. This may be the responsibility of the property corporation. Contact the property management team before repairing / replacement work(s).

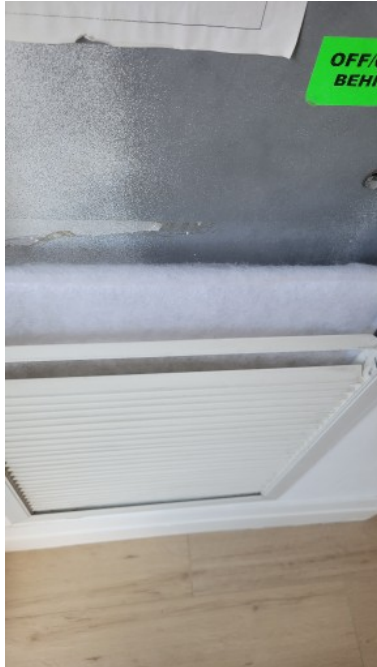
### 2.1) Filter Conditions

The filter appeared to be clean and operational at time of inspection.

Filters should be inspected monthly and replaced or cleaned as needed—typically every 1 to 3 months, depending on usage and type. A dirty or clogged filter can reduce efficiency and airflow. Recommend regular maintenance and replacement in accordance with the manufacturer's guidelines.

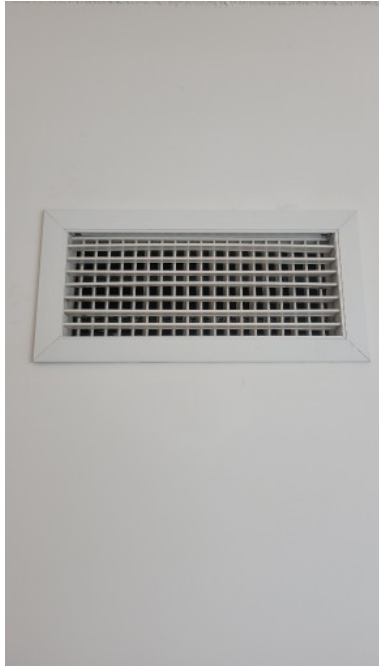
### 2.2) Distribution Type and Condition

Ductwork with registers.

The visible portions of the duct system appeared generally serviceable at the time of inspection. Ducts distribute conditioned air throughout the unit and should be kept clean and properly sealed for optimal performance. Over time, dust and debris can accumulate, affecting airflow and efficiency. Recommend professional cleaning every few years and sealing any visible gaps or loose connections as needed.

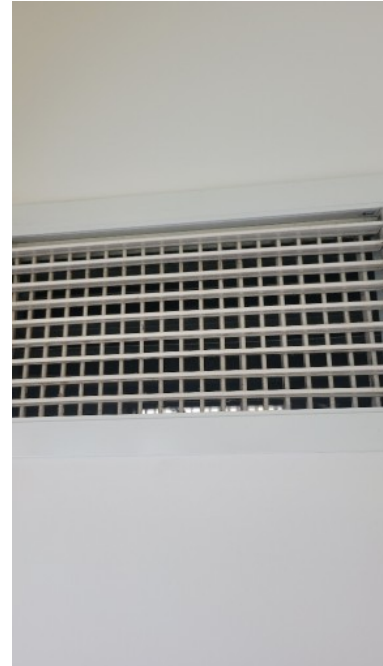
AS

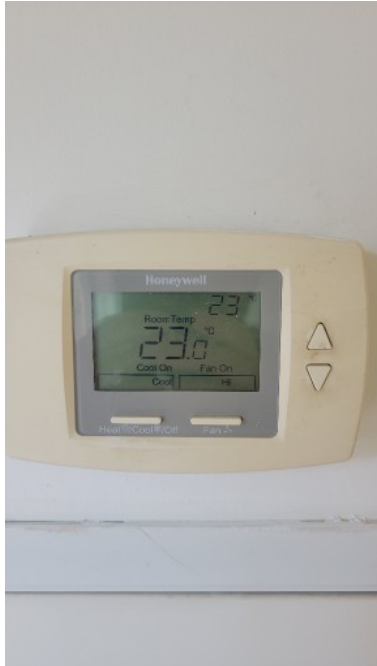
### 2.3) Thermostat Condition

The thermostat appeared to be in working or usable condition with no major discrepancies noted during the time of inspection.

The thermostat controls the temperature and operation of the HVAC system. During the inspection, it was operated to verify basic functionality and response. Thermostats should be set to the desired comfort level and used according to the manufacturer's instructions. Recommend periodic testing and replacing batteries (if applicable) as needed.

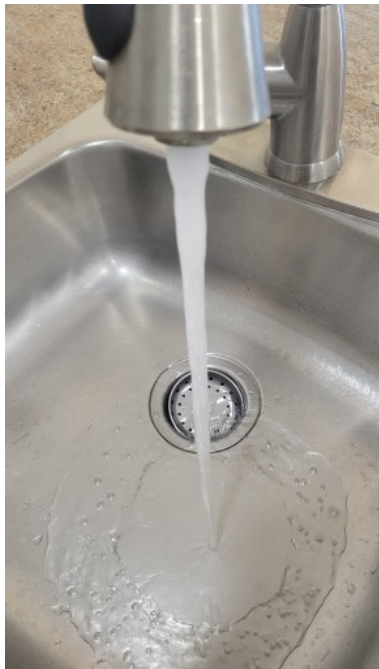
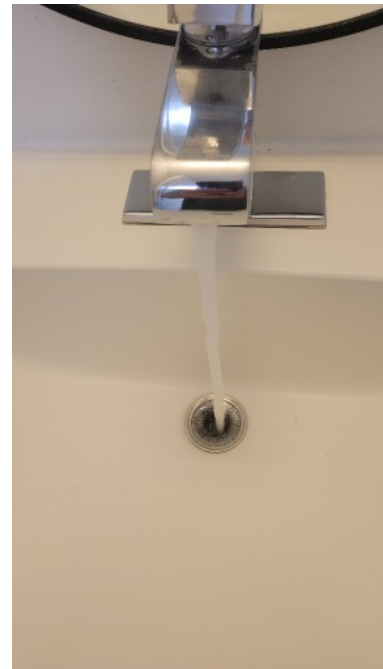
#### 3.1) Water Pressure Condition

AS

Water pressure at the unit was tested and found to be within a normal and functional range at the time of inspection. All fixtures, including sinks, shower(s), and toilet(s), produced adequate flow without noticeable drops in pressure when operated simultaneously. No signs of water hammer or pressure-related issues were observed.

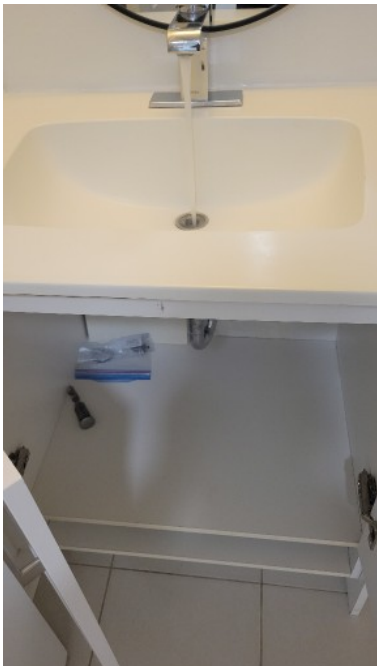
### 3.2) Drainage Condition

Drainage from sink(s), tub(s), and other plumbing fixtures was tested and found to be functional at the time of inspection. Water drained at an acceptable rate with no signs of slow drainage, gurgling, or backup, which can indicate partial blockages or venting issues. No visible leaks were observed beneath the fixtures. Regular use of strainers and periodic cleaning of drains is recommended to prevent buildup and maintain proper flow. If any signs of slow drainage or odors develop, further evaluation by a licensed plumber may be necessary.

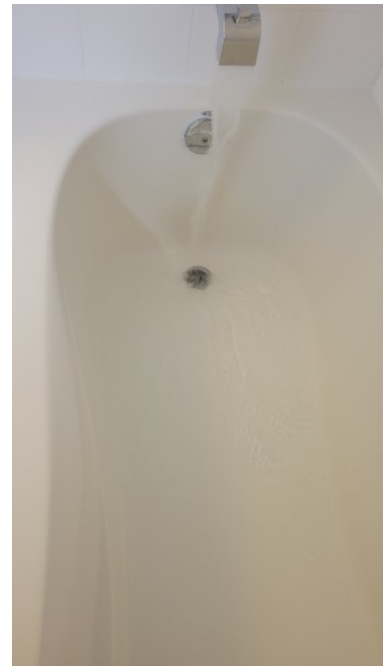
AS

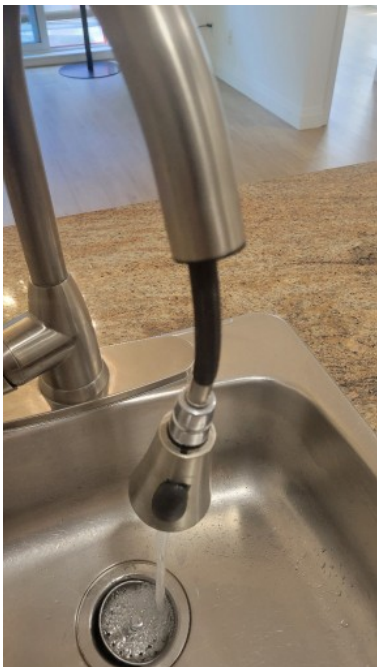
### 3.3) Faucets, Sinks, Tub(s), Shower(s), Toilet(s)

All accessible items were tested during the time of inspection and appeared to be in working and usable condition with no major discrepancies noted.

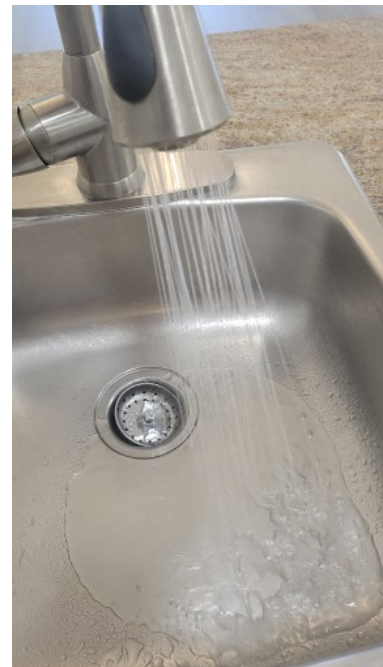
AS

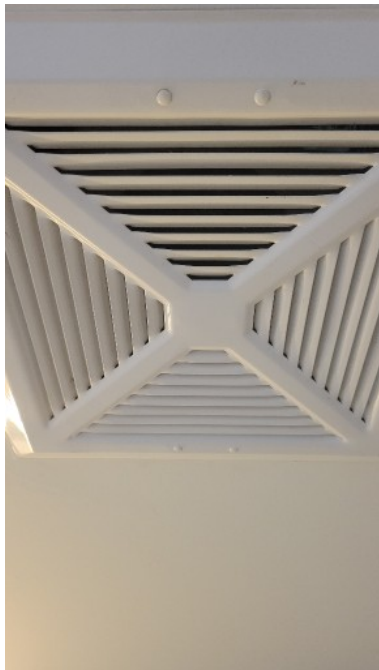
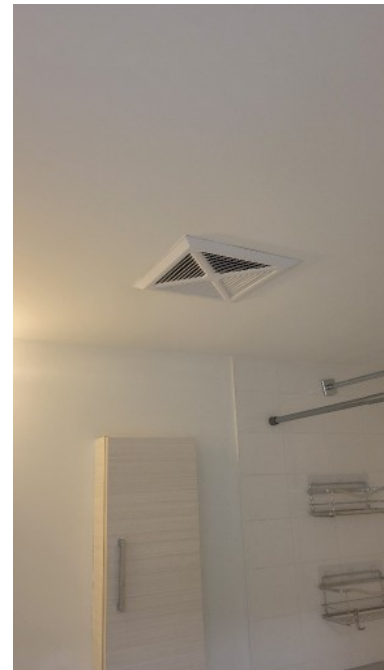
#### 4.1) Bathroom(s)

AS

The bathroom is equipped with an exhaust fan, which was tested and found to be operational at the time of inspection. However, the airflow strength was not measured, and ducting could not be visually inspected due to inaccessibility behind walls or ceilings.

It is recommended to run the fan during and after showers for at least 20–30 minutes to ensure proper ventilation. Regular cleaning of the fan cover and blades is also advised to maintain efficiency and extend the life of the unit.

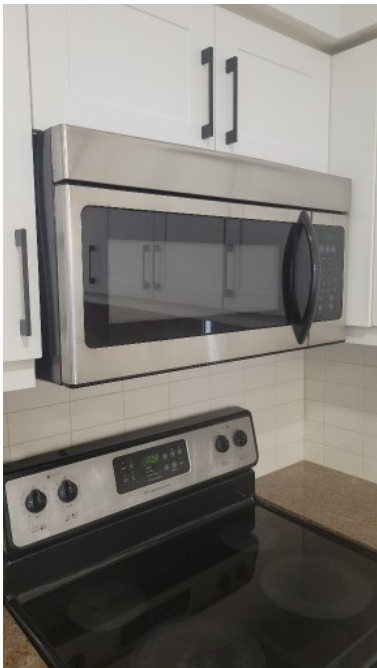
The kitchen is equipped with a range hood located above the stove. The ventilation system was tested and found to be operational at the time of inspection. Filters should be cleaned or replaced regularly according to manufacturer recommendations to maintain performance.

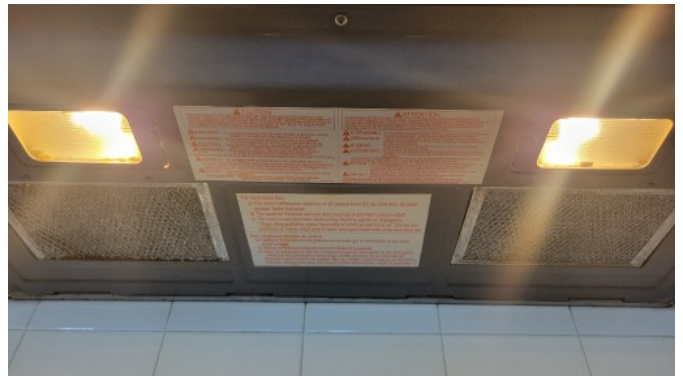
#### 4.2) Kitchen

AS

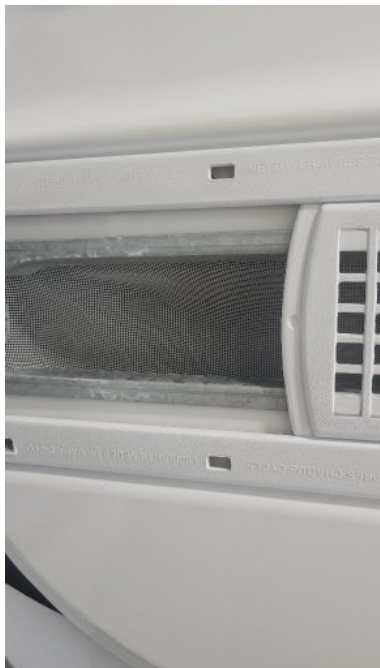
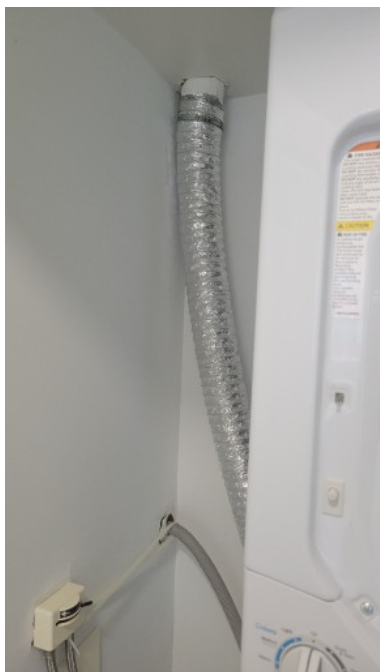
#### 4.3) Laundry Room

AS

The laundry area is equipped with a dryer exhaust vent serving the clothes dryer. The ventilation system was inspected to the extent accessible and was operational at the time of inspection. Proper ventilation is important for removing heat, moisture, and lint from the laundry space. The dryer lint screen should be cleaned after each use, and the vent duct should be professionally cleaned on a routine basis—typically every 1–2 years—to maintain safe and efficient operation.

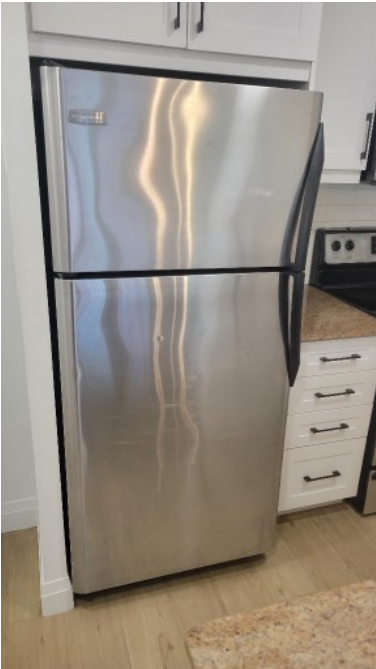
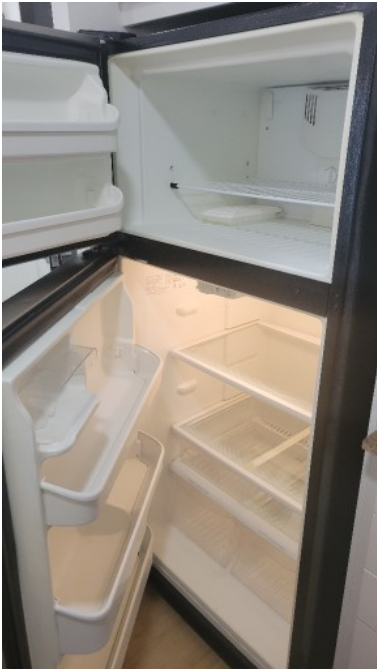
The refrigerator-freezer appeared to be in working and usable condition at the time of inspection, with no major discrepancies observed during basic testing..

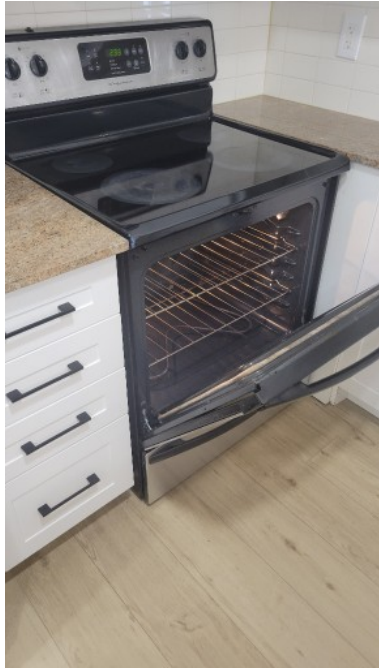
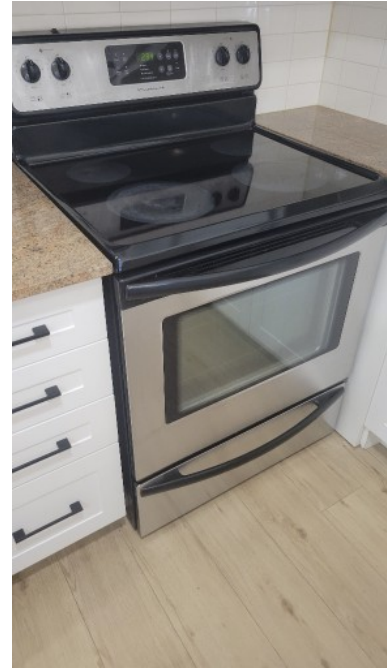
5.2) Oven-Stove

AS

The oven and stove appeared to be in working and usable condition at the time of inspection, with no major discrepancies observed during basic testing.

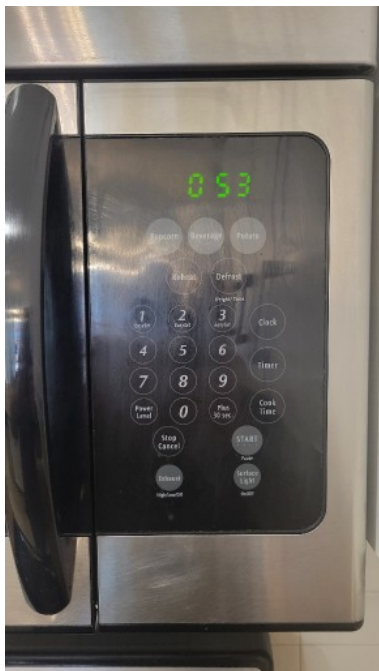
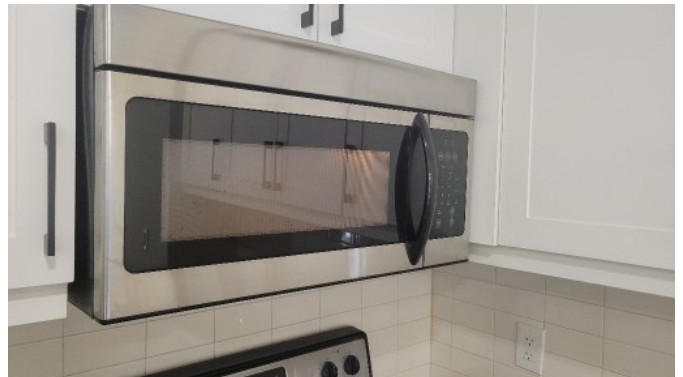
### 5.3) Microwave

AS

The microwave appeared to be in working and usable condition at the time of inspection, with no major discrepancies observed during basic testing.

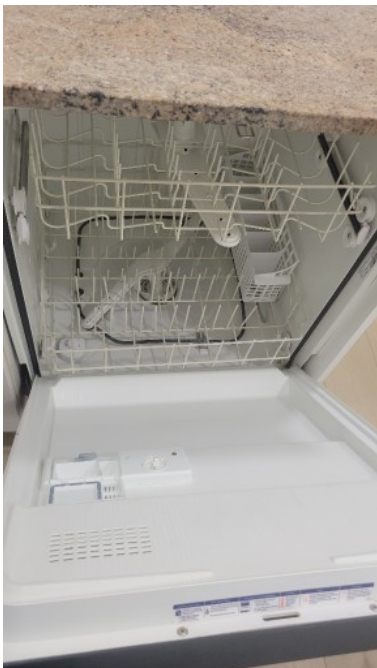
#### 5.4) Dishwasher

The dishwasher appeared to be in working and usable condition at the time of inspection, with no major discrepancies observed during basic testing.

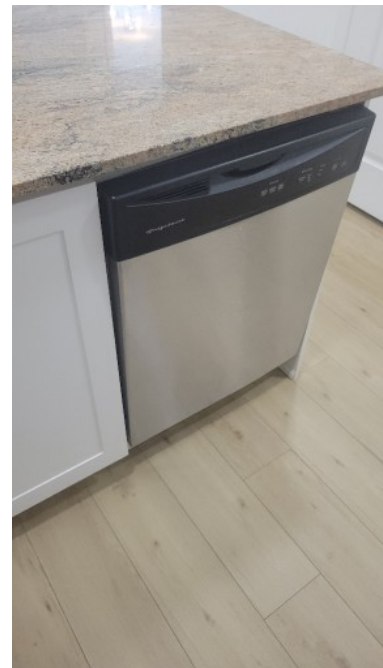
AS

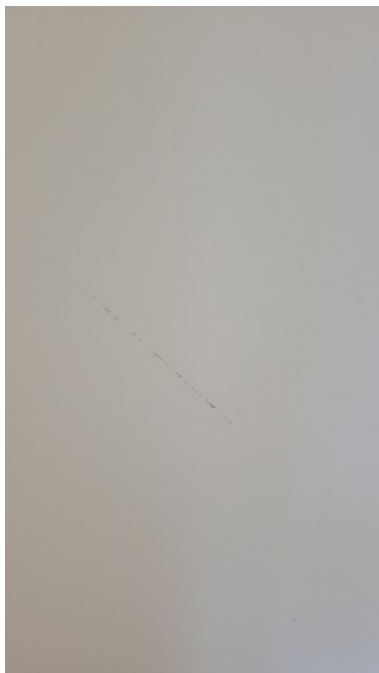
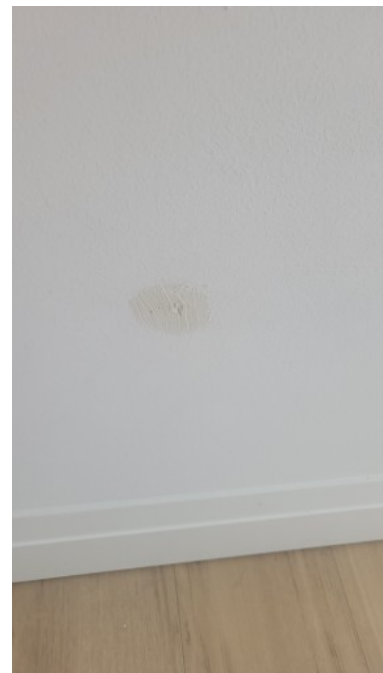
#### 6.1) Walls and Ceilings

The accessible areas of walls and ceilings were reviewed during the inspection. There were common minor settlement type cracks, chips, and scuff marks observed. These conditions are common in most homes which were previously occupied.

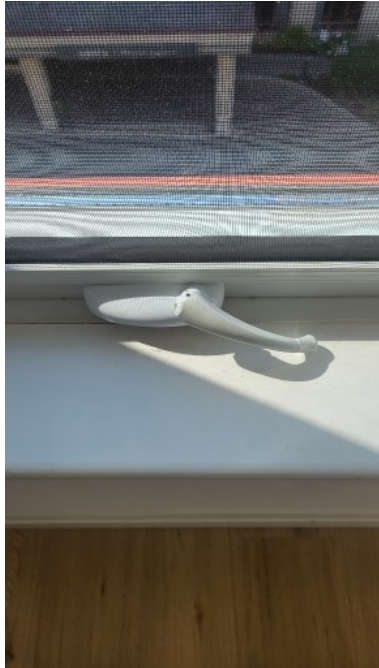
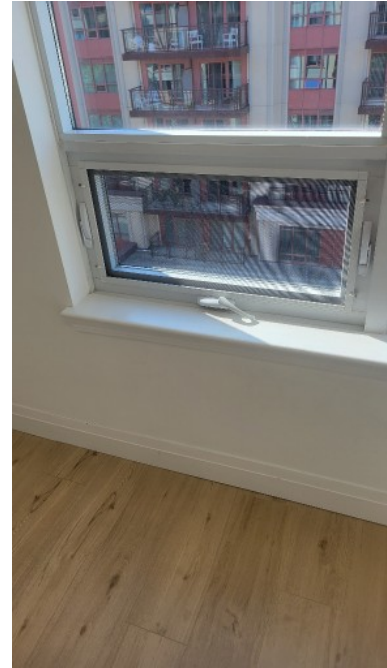
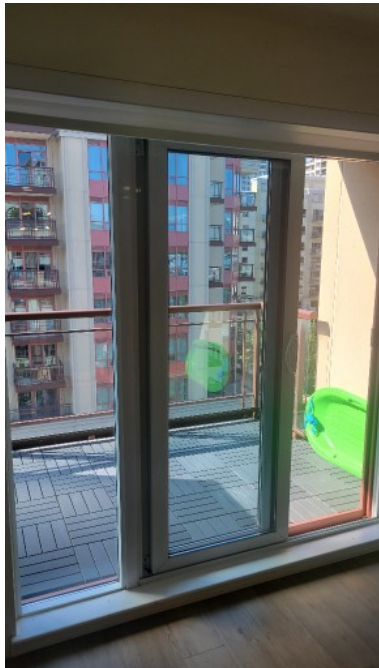
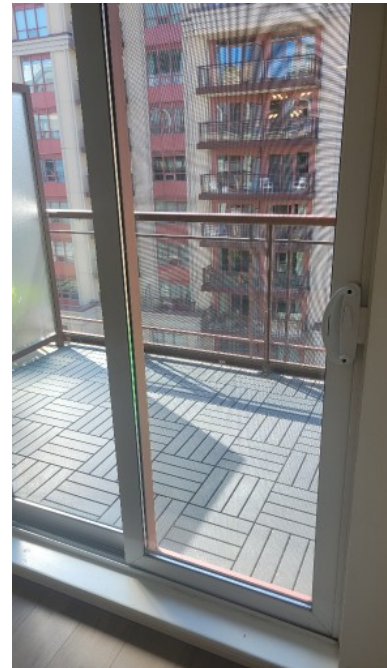
## 6.2) Windows and Sliding Door(s)

R

All accessible windows and balcony doors were reviewed at the time of inspection. The bedroom window crank is not operational. Recommend repair.

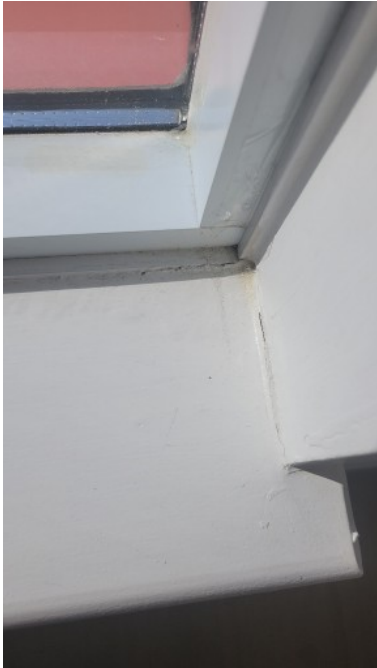
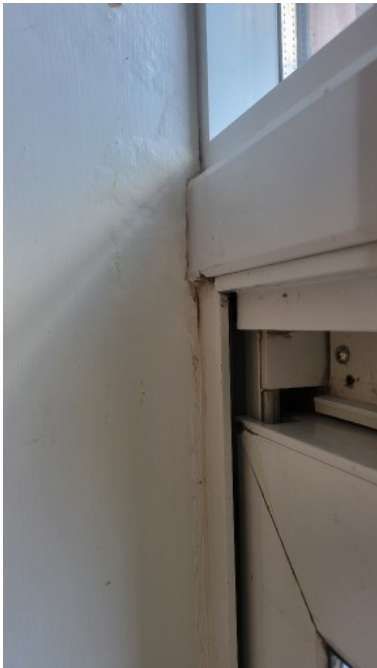
The sealant near the window sills and window trim generally starts to split over time. This is common in most homes. It is advisable to apply caulk/silicone to close the gaps and prevent moisture/dirt/debris.

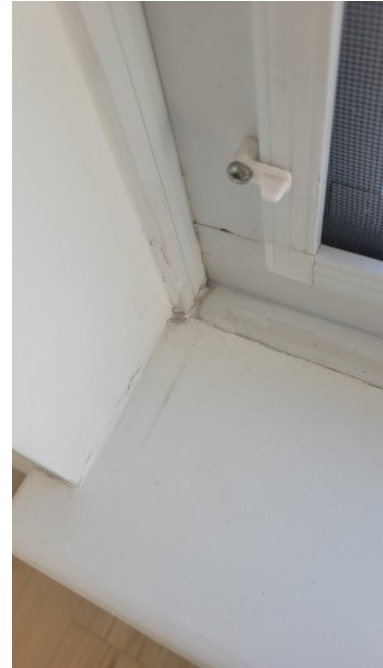
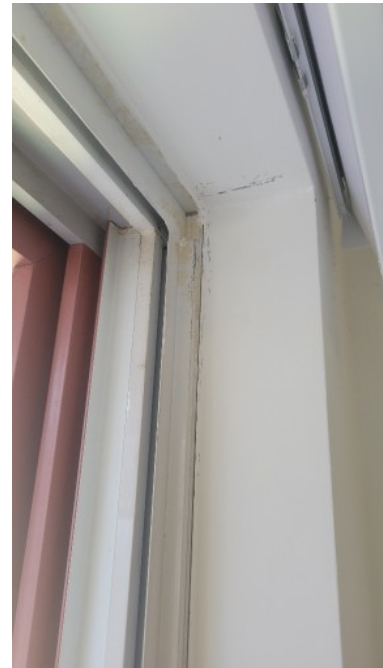
### 6.3) Window Sills, Trim, and Casing

RM

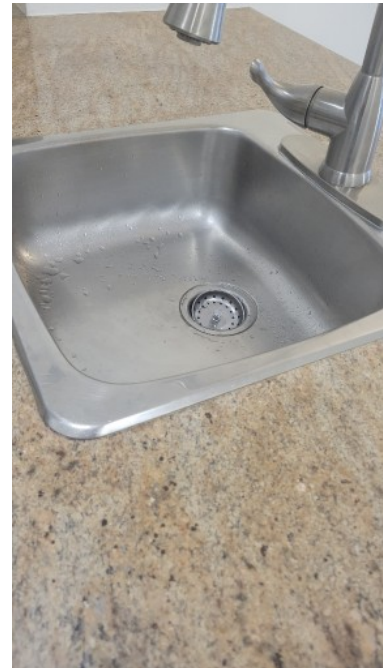
#### 6.4) Interior Bathroom(s) and Kitchen Sealant

AS

Caulking and silicone sealants around plumbing fixtures, countertops, sinks, tub(s), and shower(s) are subject to shrinkage, cracking, or separation over time due to normal building movement and seasonal changes. This is common in most homes. Gaps or deteriorated sealant should be repaired or re-caulked as needed to maintain a proper seal, prevent moisture intrusion, and reduce the accumulation of dirt, debris, or mold. Routine inspection and maintenance are recommended to prolong the service life of finishes.

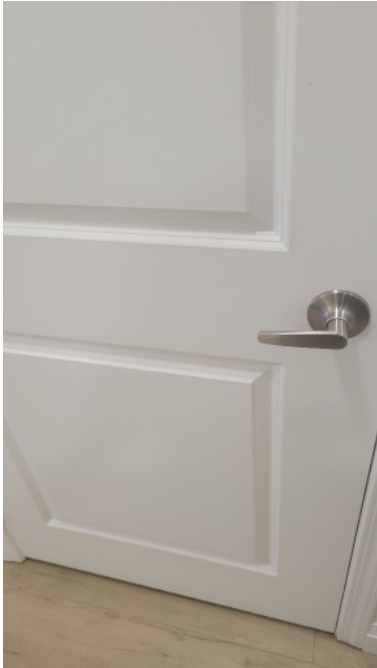
The bedroom and bathroom doors do not properly latch when closed. This is most likely due to misalignment between the door latch and strike plate. Minor adjustment to the strike plate and/or door hardware is recommended to ensure the doors latch and close properly.

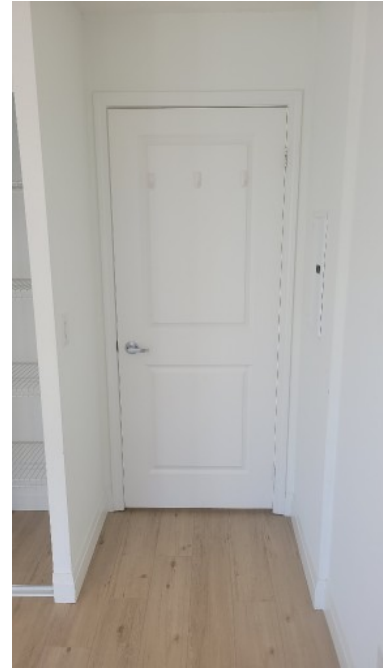
### 6.5) Interior Doors and Hardware

RM

All visible portions of the doors and associated hardware were inspected.

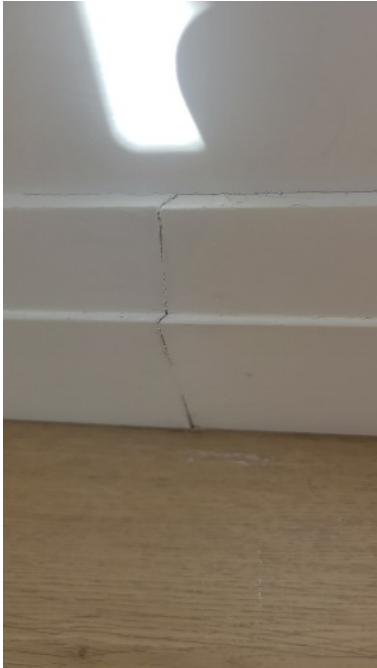
#### 6.6) Baseboards, Trim, Molding & Door Frames

The sealant and joints along the baseboards, door frames, molding, and trim can begin to separate over time due to normal expansion and contraction. This is common in most homes. It is advisable to re-caulk these gaps as needed to improve appearance and help prevent dust, drafts, and debris from accumulating behind the trim.

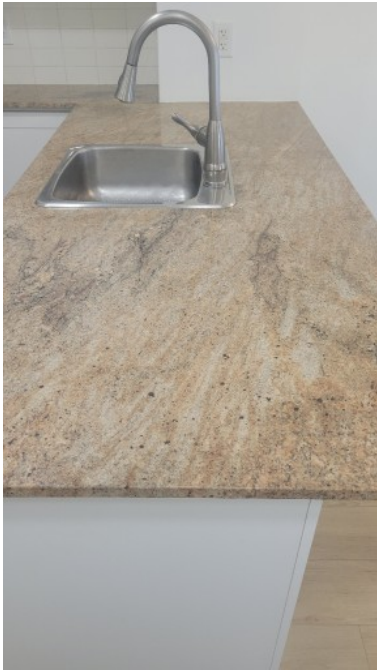
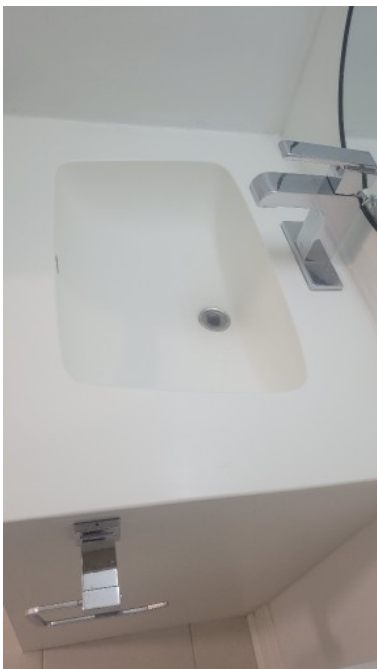
All visible portions of the countertops were inspected and appeared to be in working and usable condition at the time of inspection, with no major discrepancies observed.

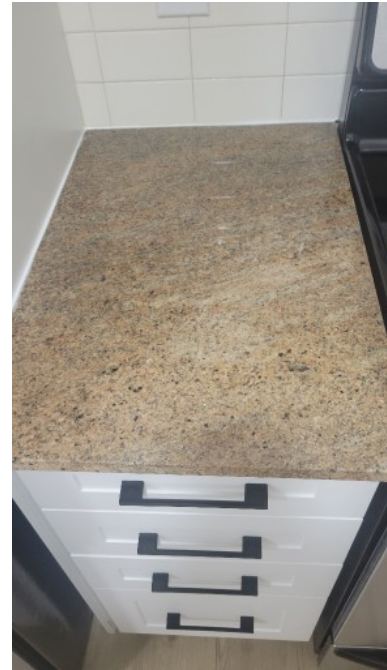
#### 7.1) Countertops

AS

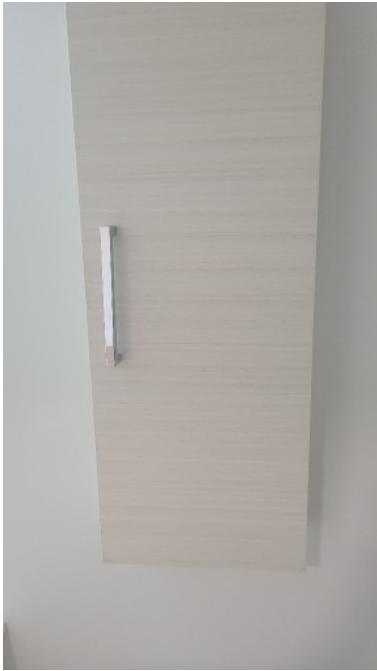
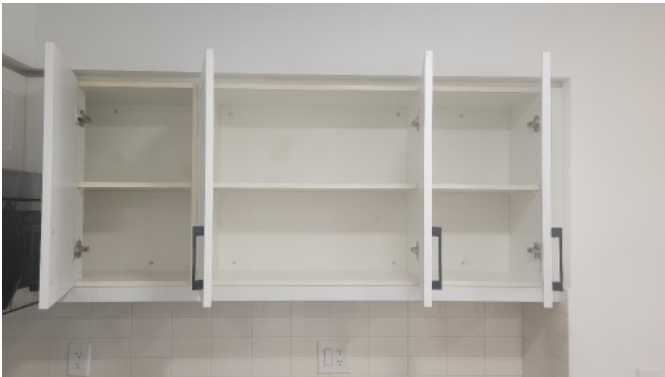
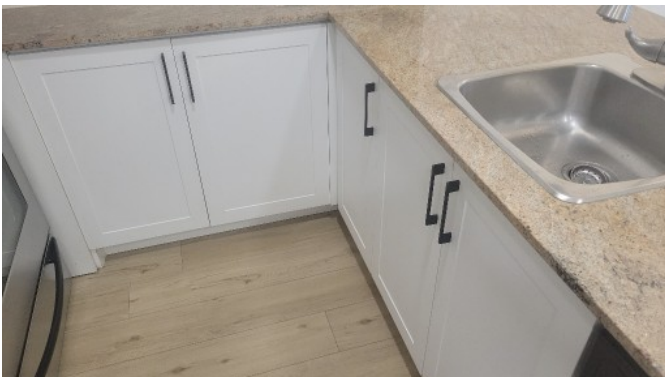
**7.2) Cabinets**

All visible portions of the cabinets were inspected and appeared to be in working and usable condition at the time of inspection, with no major discrepancies observed.

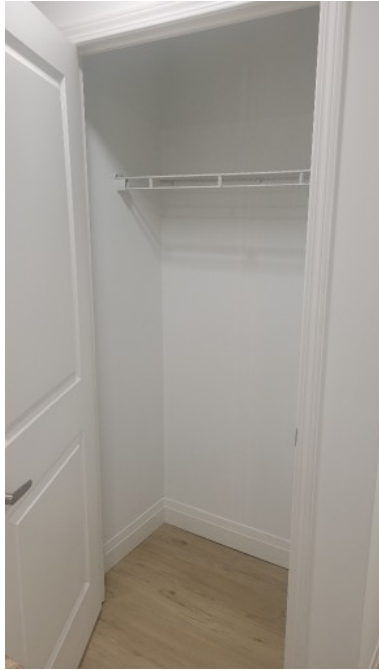
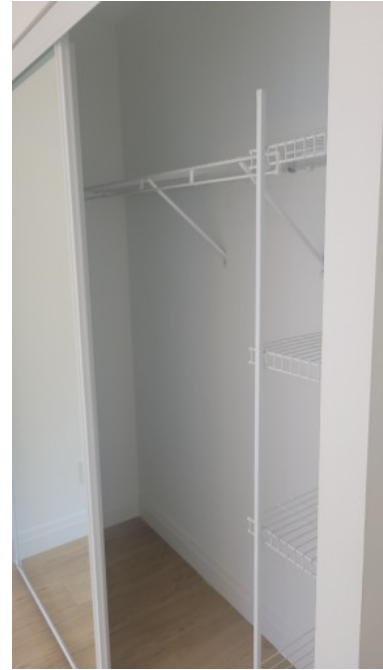
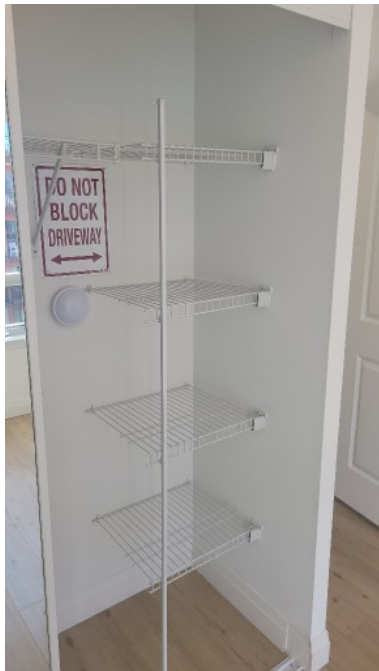
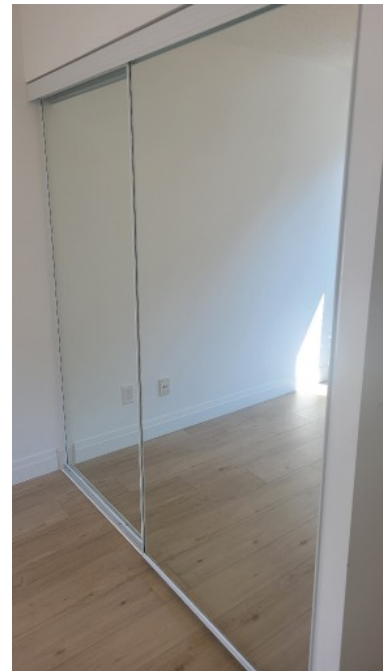
**7.3) Closets**

AS

All visible portions of the closets were inspected and appeared to be in working and usable condition at the time of inspection, with no major discrepancies observed.

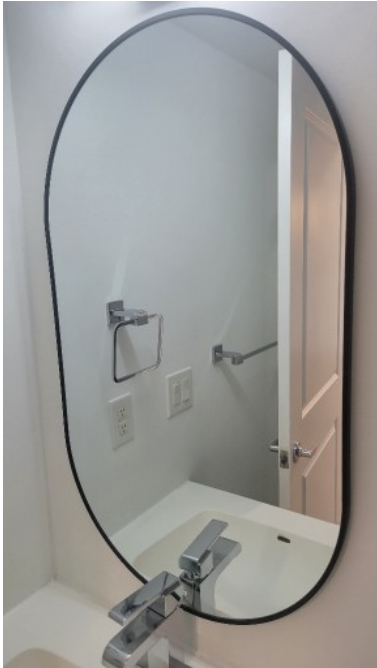
The mirror(s) located in the bathroom(s) appeared to be in working and usable condition at the time of inspection, with no major discrepancies observed.
