Inspection Report

Inspekt

Inspector: Stan Nevolovich

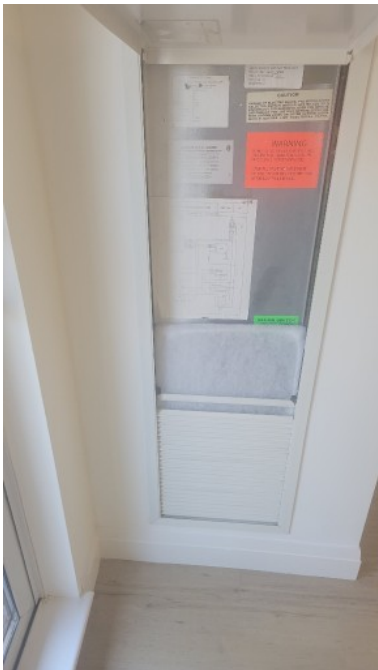
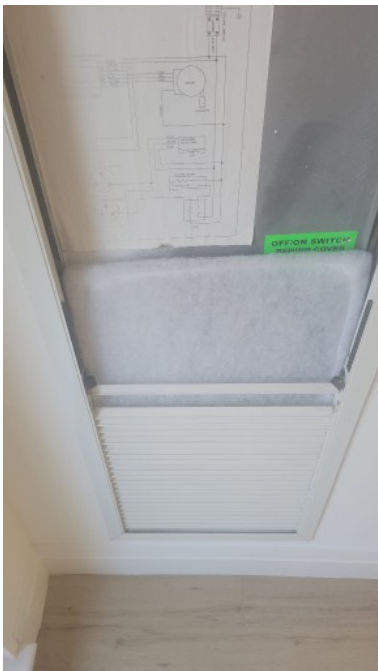
Location of Unit Living Room

Filter Condition Appears Serviceable: The item appeared to be in working or usable condition with no major discrepancies noted. This is not an indication of future operation or condition.

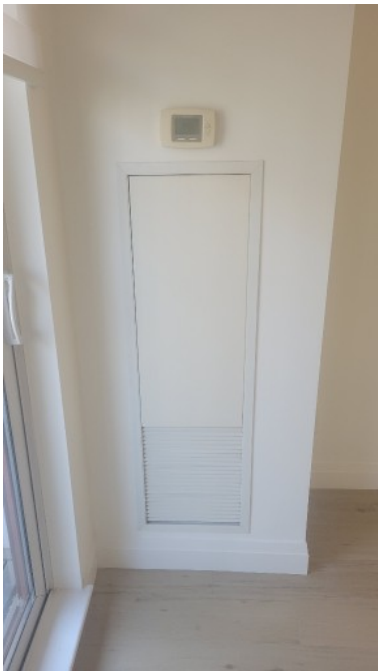
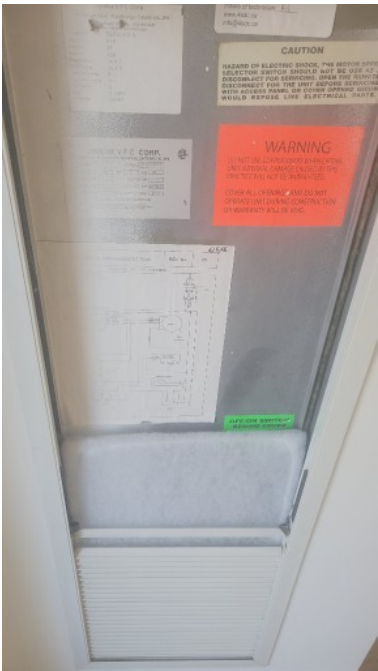
1.1) Unit Conditions

Appears Serviceable: The item appeared to be in working or usable condition with no major discrepancies noted. This is not an indication of future operation or condition.

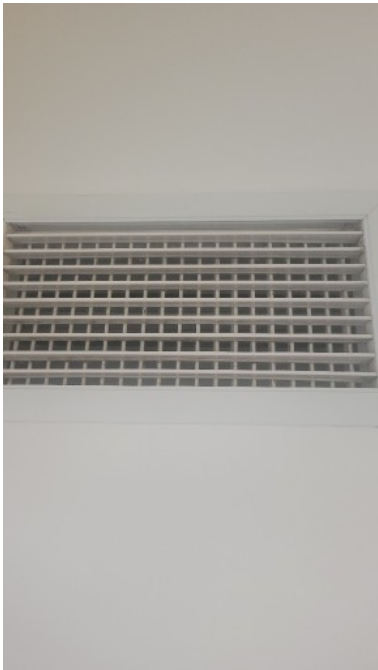
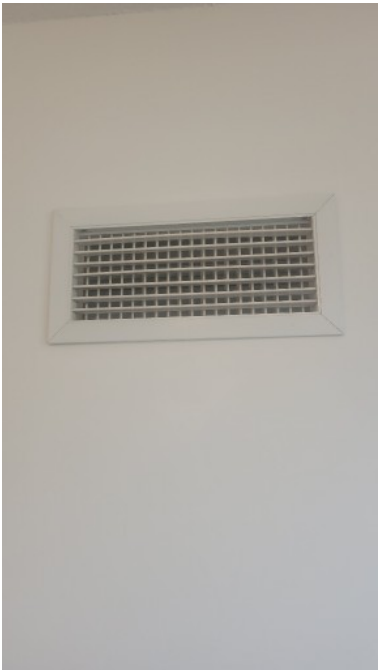
Distribution Type The visible areas of the heat distribution system is ductwork with registers.

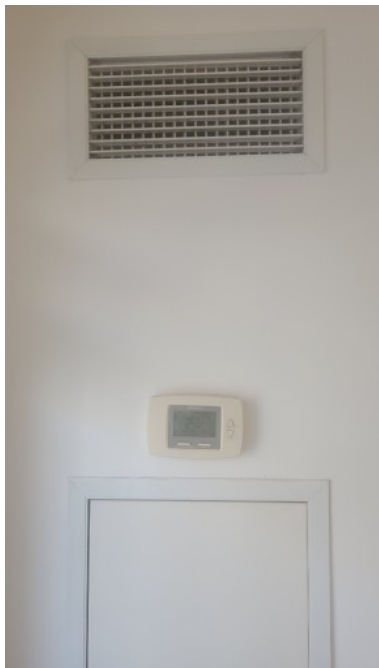
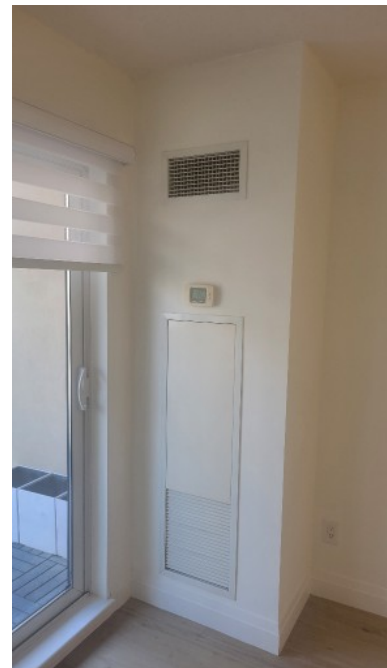
1.2) Distribution Conditions

The visible and accessible areas of the distribution system appeared to be in serviceable condition at the time of inspection.

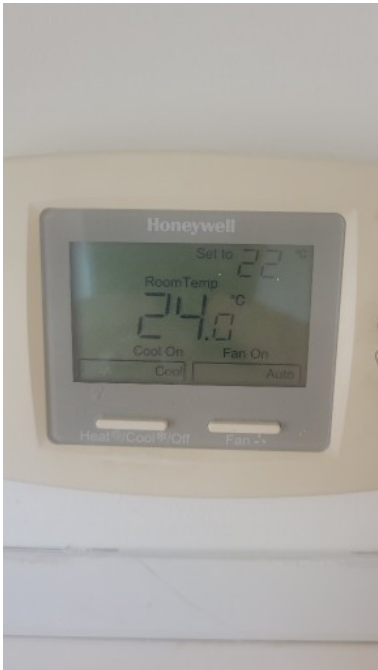
1.3) Thermostat Condition

The normal operating controls appeared to be serviceable at the time of the inspection.

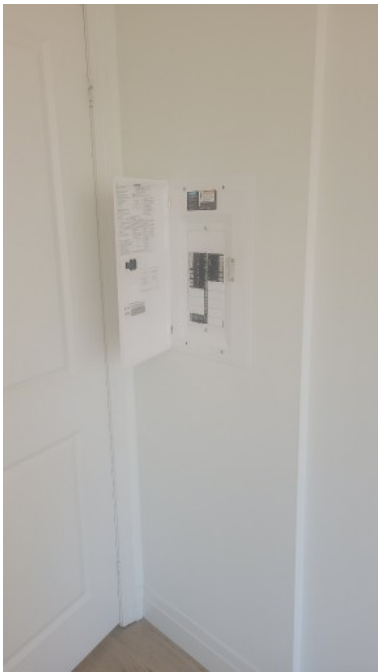
Electric Panel Location The main electric panel is located at the bedroom.

Panel Amperage Rating The electrical capacity of main breaker was listed / labeled as 125 amps.

The Electrical Panel is equipped with circuit breakers and all breakers were on during the time of inspection. The panel appears to be generally in good condition and is labeled.

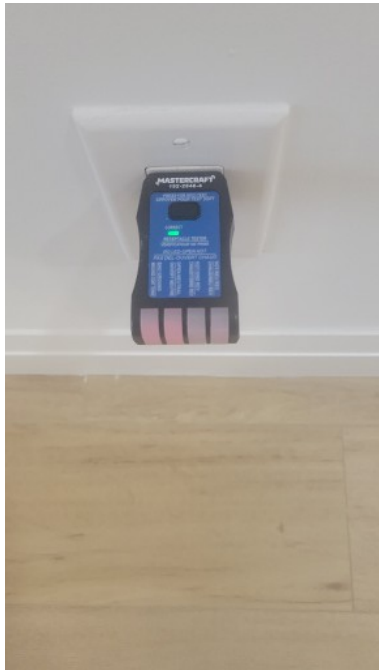
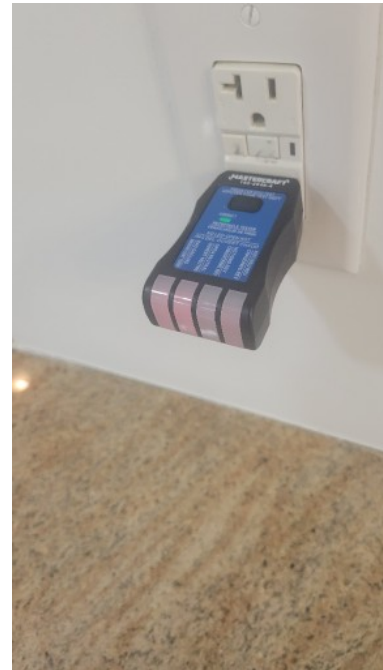
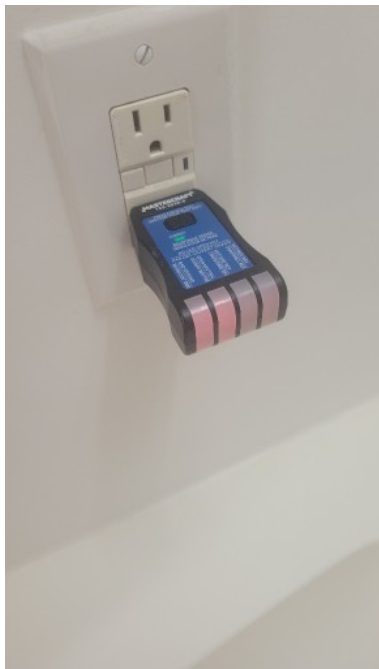
2.2) Condition

All accessible electrical outlets were tested.

Appears Serviceable: The item appeared to be in working or usable condition with no major discrepancies noted. This is not an indication of future operation or condition.

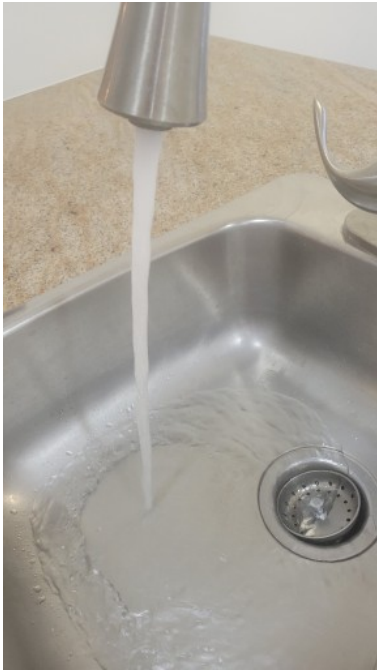
Water pressure at the unit was tested and found to be within a normal and functional range at the time of inspection. All fixtures, including sinks, showers, and toilets, produced adequate flow without noticeable drops in pressure when operated simultaneously. No signs of water hammer or pressure-related issues were observed. For optimal performance and to prevent stress on plumbing fixtures, residential water pressure should typically range between 40–80 psi. Recommend monitoring over time and consulting building management if pressure fluctuations occur.

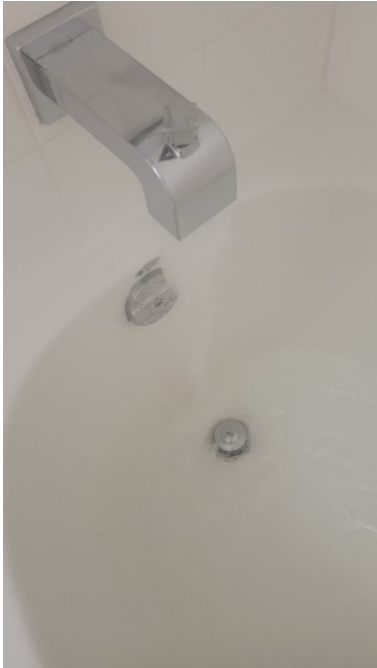
Drainage from sink(s), tub(s), and other plumbing fixtures was tested and found to be functional at the time of inspection. Water drained at an acceptable rate with no signs of slow drainage, gurgling, or backup, which can indicate partial blockages or venting issues. No visible leaks were observed beneath the fixtures. Regular use of strainers and periodic cleaning of drains is recommended to prevent buildup and maintain proper flow. If any signs of slow drainage or odors develop, further evaluation by a licensed plumber may be necessary.

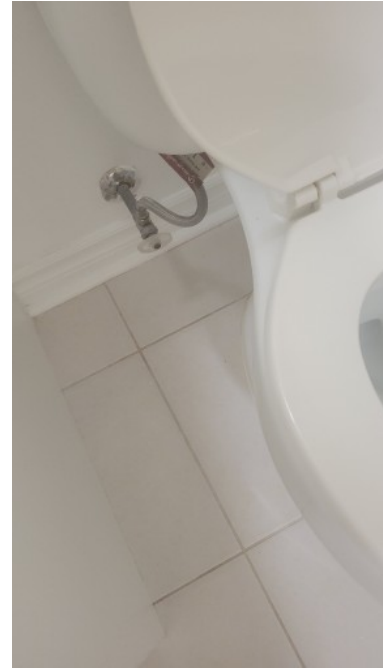
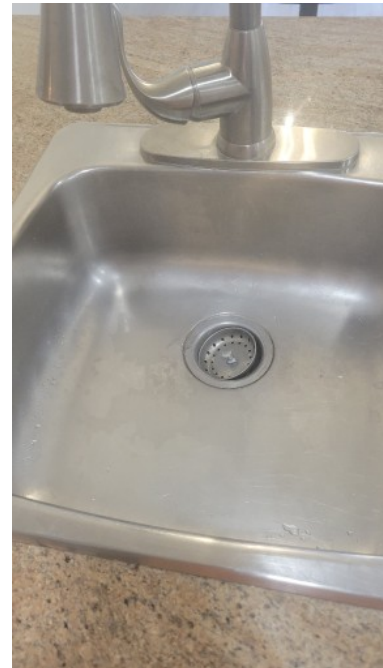
3.3) Inspector Feedback

All faucets were tested and drained. No signs of leaking faucets or vanities. This was during the inspection and does not guarantee future use. For best practice please make sure that only water can be drained and no foreign objects such as grease, paint. If the drains become clogged or faucets start leaking It is suggested that a "Licensed Plumbing Contractor" be contacted for further evaluation and repair.

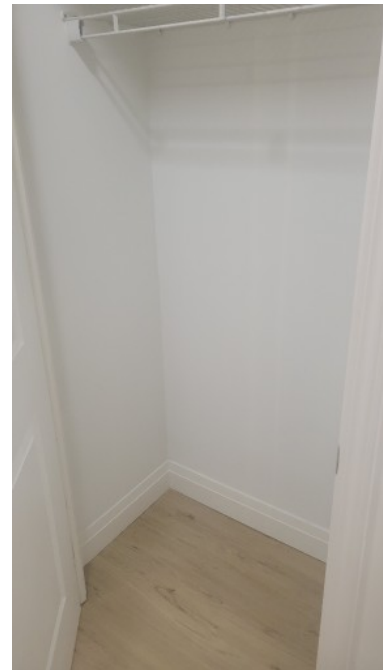
4.1) Wall Conditions

Appears Serviceable: The item appeared to be in working or usable condition with no major discrepancies noted. This is not an indication of future operation or condition.

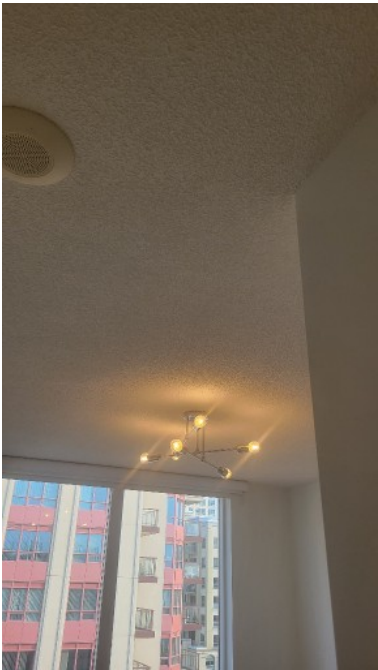
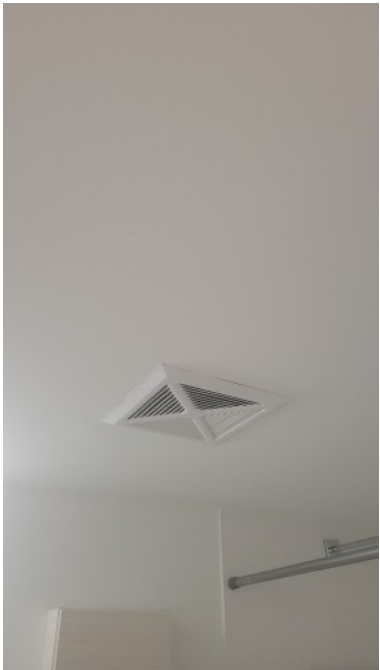
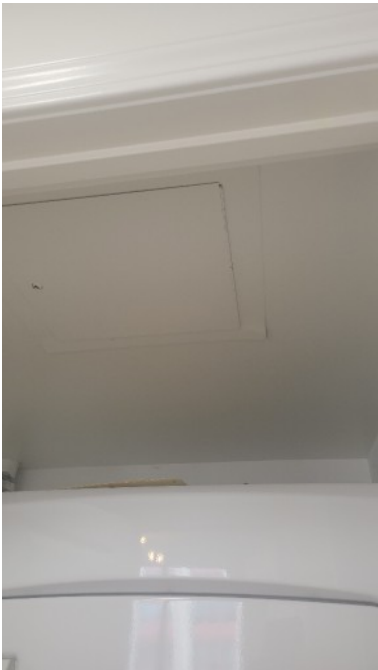
4.2) Ceiling Conditions

Appears Serviceable: The ceiling appeared to be in working or usable condition with no major discrepancies noted. This is not an indication of future operation or condition.

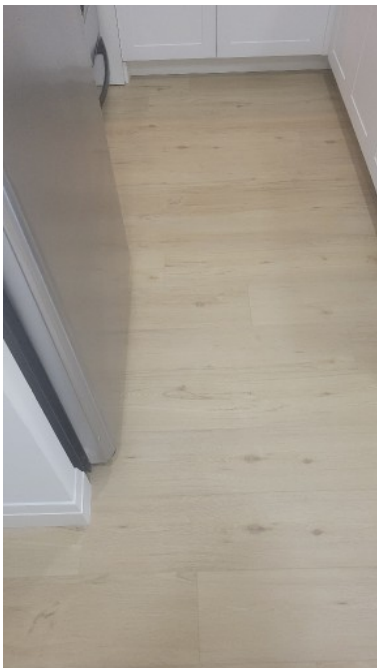
Appears Serviceable: The item appeared to be in working or usable condition with no major discrepancies noted. This is not an indication of future operation or condition.

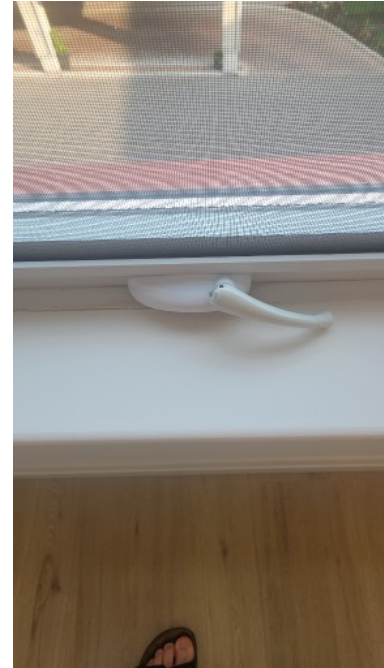
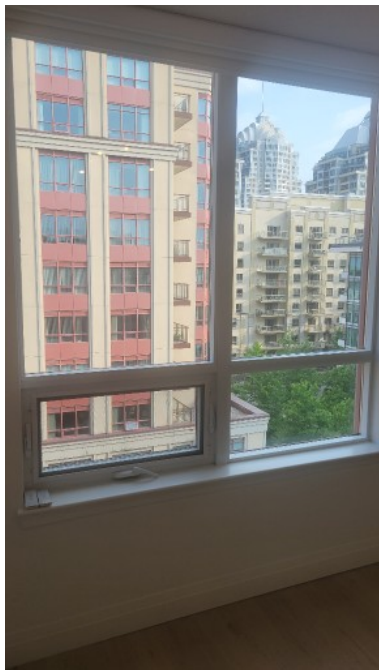
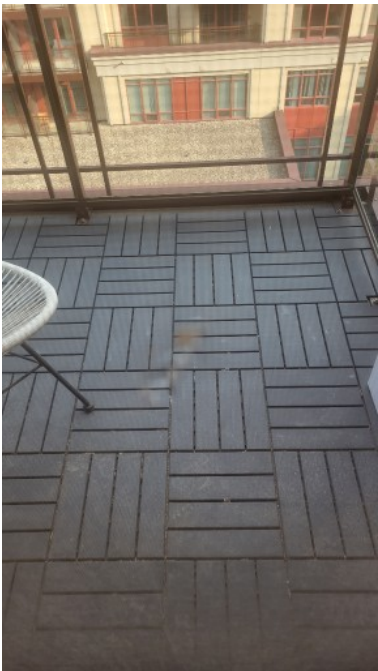
4.4) Interior Window Conditions

Some of the window screens were ripped and / or torn as per photo

The sample of windows tested were operational at the time of the inspection.

A few small cracks noted on caulking near window sill. This is common. It's recommend to have these gaps sealed to avoid moisture getting inside the cracks.

Recommend repairs as needed.

It is recommended to seal the caulking to avoid moisture and mildew build up. Recommend repairs as needed.

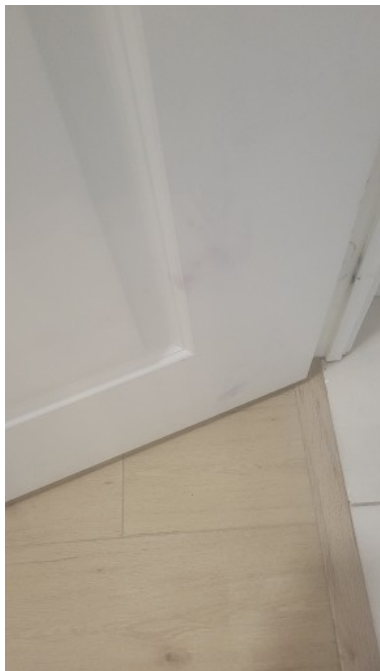
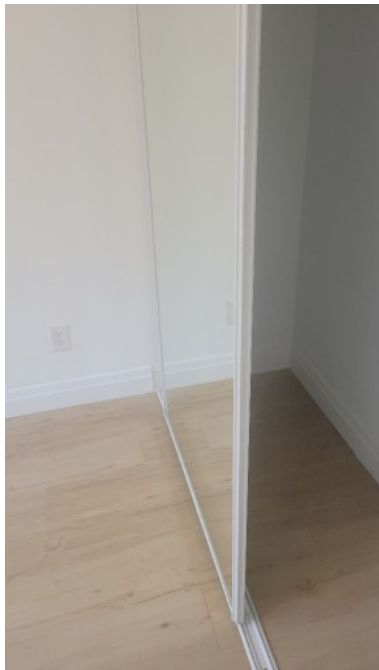
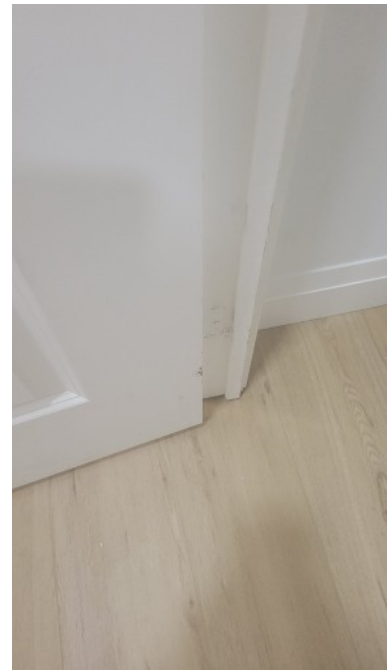
4.5) Interior Door Conditions

The interior doors appeared to be in serviceable condition at the time of the inspection. There were some scuff marks noted on the laundry door and main closet door. Recommend repairs as needed.

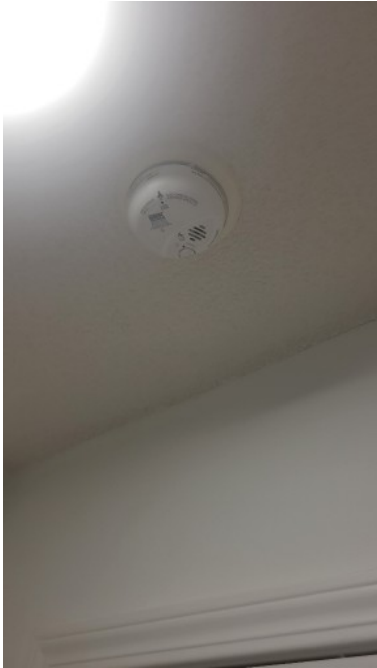
4.6) Smoke Detector Conditions

Smoke alarms were observed in the unit and appeared to be properly installed in required locations, including near sleeping areas. Units responded to the test button at the time of inspection, indicating power was present. However, testing the sensor's actual ability to detect smoke is beyond the scope of this inspection.

It is recommended that smoke alarms be tested monthly, batteries (if applicable) replaced annually, and the units themselves replaced every 10 years, per manufacturer guidelines. Consider confirming the age of the alarms and replacing any units that are outdated or not

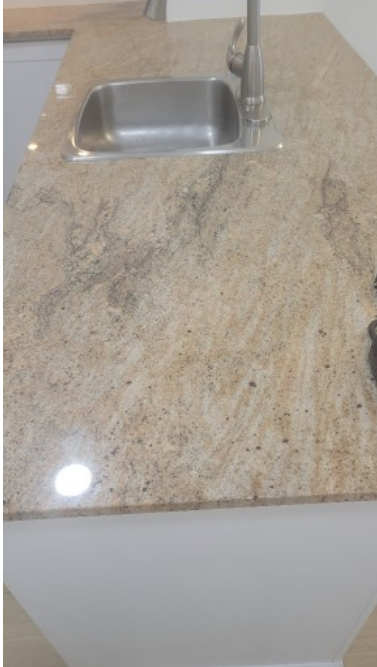
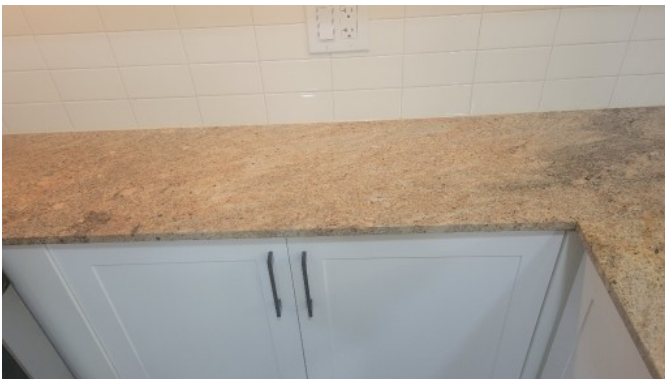
The visible portion kitchen counters appeared to be in serviceable condition at the time of the inspection. No major cracks or loose countertops noted.

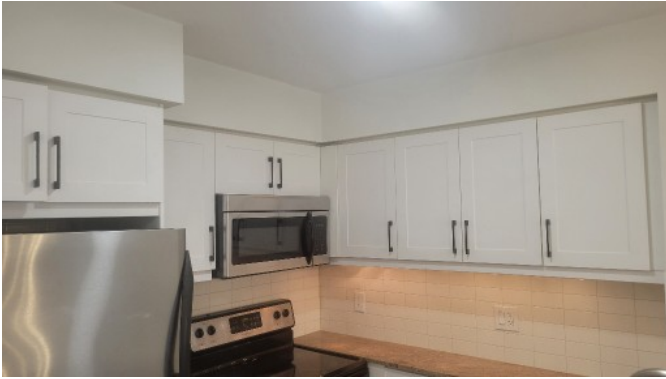
The kitchen cabinets appeared to be in serviceable condition at the time of inspection.

The kitchen cabinets showed evidence of minor wear.

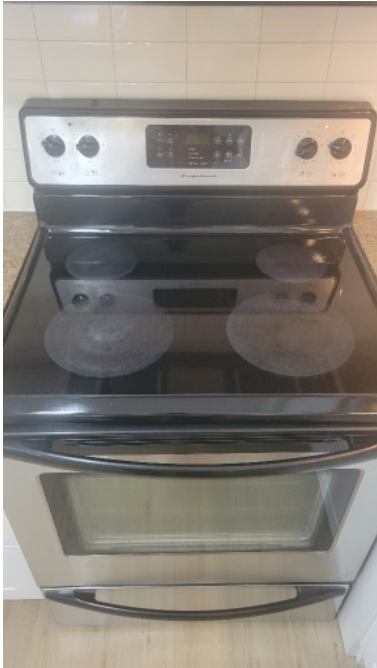
Stove - Type The oven is electric.

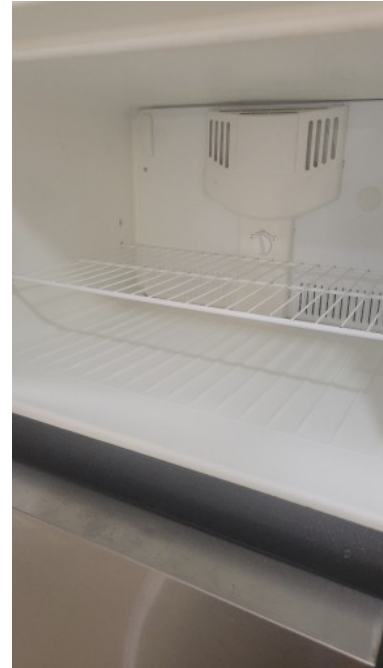
5.4) Refrigerator Condition

Appears Serviceable: The item appeared to be in working or usable condition with no major discrepancies noted. This is not an indication of future operation or condition.

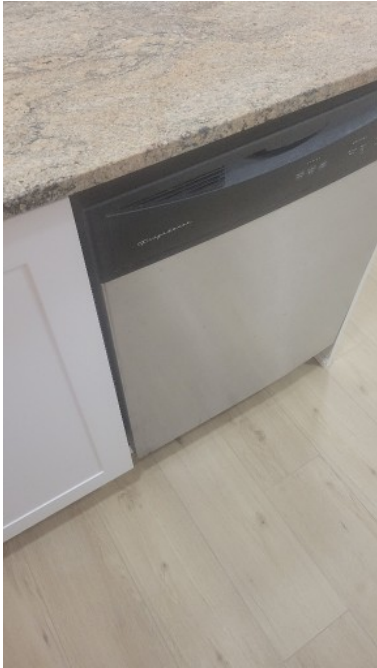
Appears Serviceable: The item appeared to be in working or usable condition with no major discrepancies noted. This is not an indication of future operation or condition. It is recommended to do a full cycle.

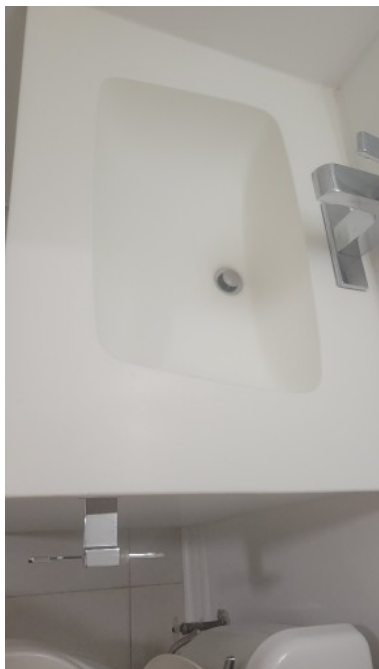
6.1) Condition

Appears Serviceable: The item appeared to be in working or usable condition with no major discrepancies noted. This is not an indication of future operation or condition.

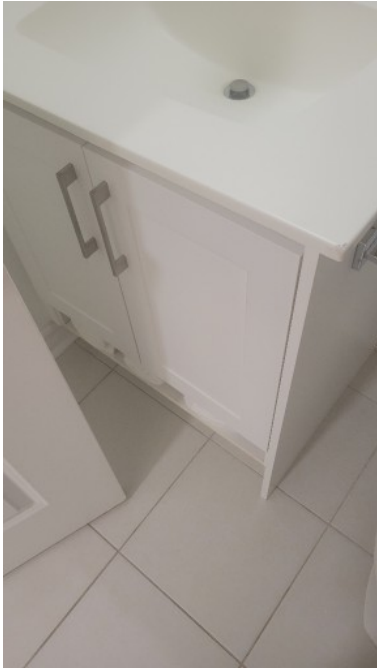
Appears Serviceable: The item appeared to be in working or usable condition with no major discrepancies noted. This is not an indication of future operation or condition.

Some additional nail holes noted but does not seem to impact the operation of the vanity during the time of inspection.

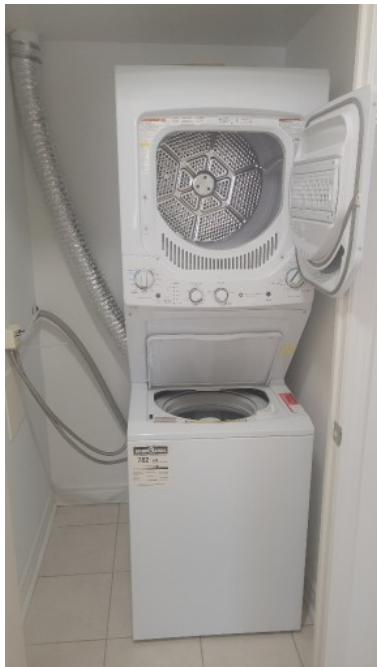
Appears Serviceable: The item appeared to be in working or usable condition with no major discrepancies noted. This is not an indication of future operation or condition.

It is recommended to run a full cycle of laundry machines to make sure there are no major issues.

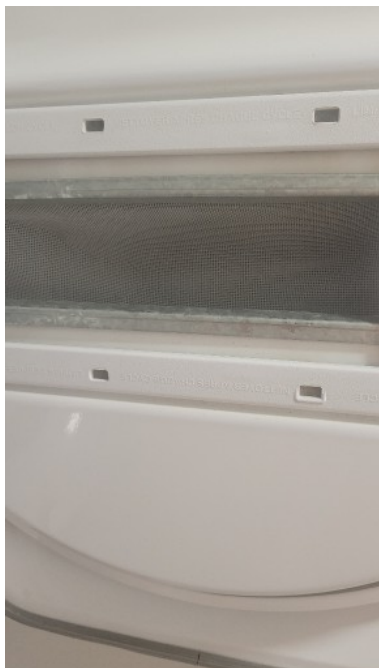
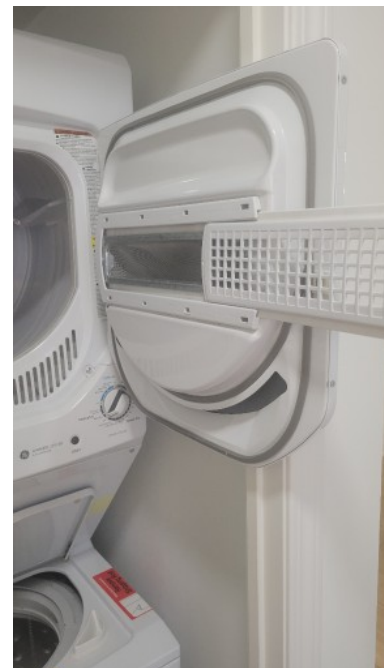
7.3) Condition

The dryer lint screen was observed to be in place and functional at the time of inspection. The screen should be cleaned after every dryer cycle to help ensure proper airflow and reduce the risk of overheating or fire. It is also recommended to periodically rinse the screen with water to remove any detergent or fabric softener residue that may restrict airflow.

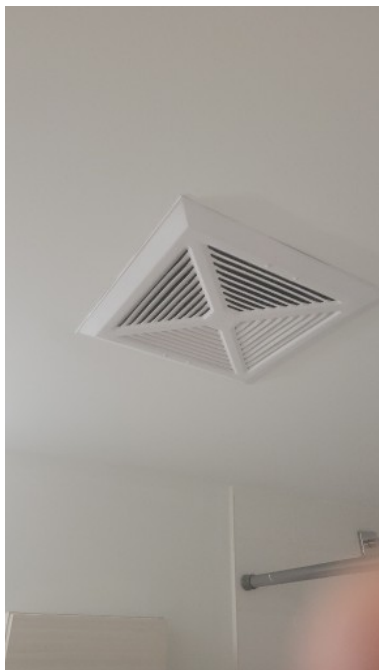
8.1) Condition

The bathroom is equipped with an exhaust fan, which was tested and found to be operational at the time of inspection. However, the airflow strength was not measured, and ducting could not be visually inspected due to inaccessibility behind walls or ceilings.

It is recommended to run the fan during and after showers for at least 20–30 minutes to ensure proper ventilation. Regular cleaning of the fan cover and blades is also advised to maintain efficiency and extend the life of the unit.

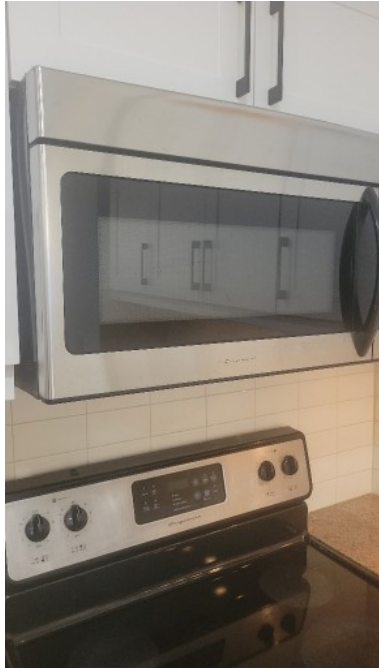
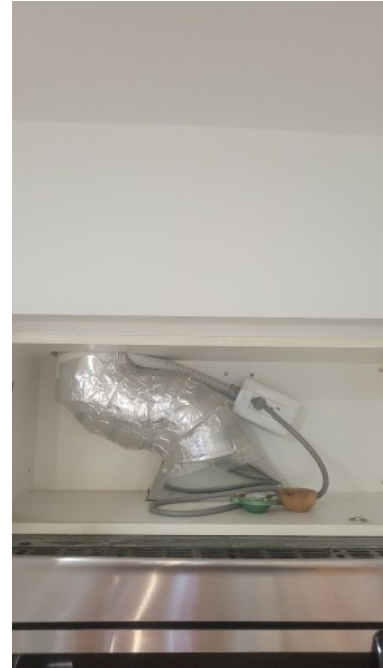
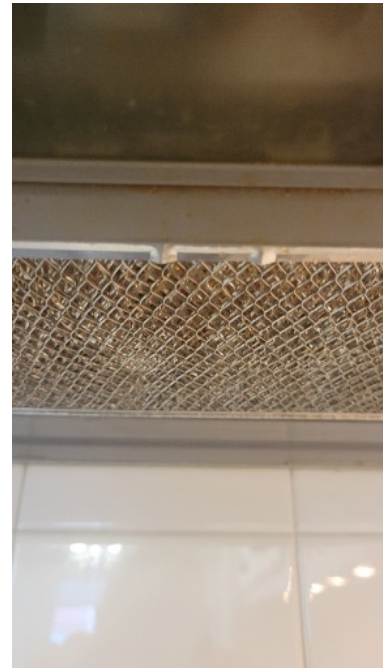
8.2) Condition

The kitchen is equipped with a range hood located above the stove. The ventilation system was tested and found to be operational at the time of inspection.

Filters should be cleaned or replaced regularly according to manufacturer recommendations to maintain performance.

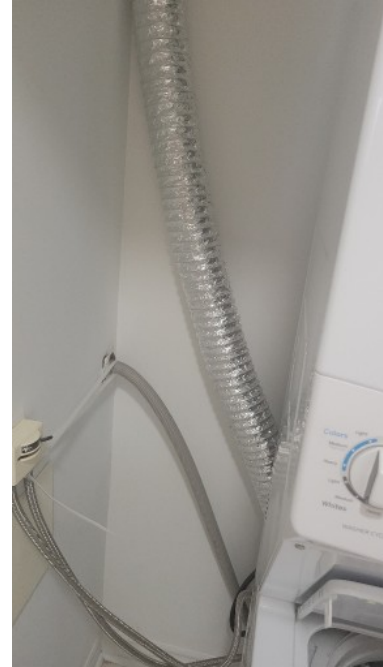
8.3) Condition

The dryer vent system in this condominium unit was inspected to the extent accessible. The vent appears to be a rigid or semi-rigid metal duct, as recommended, and is properly connected to the dryer. However, due to typical construction in condominium buildings, the full length of the duct—often concealed within walls or ceilings—could not be visually inspected.

No visible signs of damage or disconnection were noted at the accessible portions. It is important

to ensure that the dryer vent is professionally cleaned on a routine basis, typically every 1–2 years, as lint buildup in concealed ductwork can pose a significant fire hazard and reduce dryer efficiency. Recommend confirming with building management when the last cleaning was performed and whether regular maintenance is scheduled.
